Campaign No. 2015020004, March 2015

SUBJECT: **Model 906 (Sprinter), Model Year 2015**
B-Pillar Abutting Wedge

Daimler AG (DAG), the manufacturer of Mercedes-Benz and Freightliner Sprinter vehicles, has determined that Model Year 2015 Mercedes-Benz and Freightliner Sprinter vehicles may be manufactured with an incorrectly installed abutting wedge at the B-pillar. The Model Year 2015 vehicles required an abutting wedge at the B-pillar for door opening forces after a severe frontal impact crash. If a vehicle with an incorrectly installed abutting wedge is involved in a severe frontal collision, it may require significantly greater forces to open the doors. To correct this condition an authorized Mercedes-Benz or Freightliner Sprinter dealer will check the installation of the abutting wedge, and if found incorrect will correct the abutting wedge installation and replace the mounting bolts.

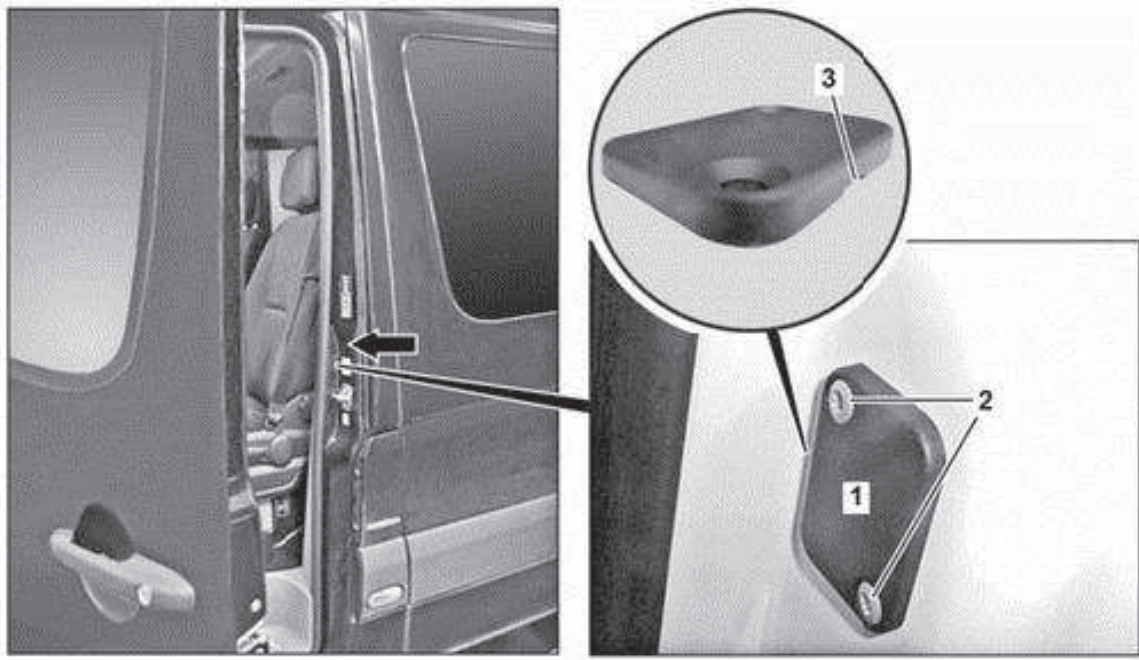
Figure 1

Check installation position of wedge-type stop (1, Figure 1) on B-pillar of driver and passenger side of vehicle:
 - The cutout (3) of the wedge-type stop (1) must face towards the vehicle's interior (arrow). If installation position of wedge-type stop (1) on B-pillar of driver **and** passenger side is **correct (OK)**: Procedure is complete.
 - If installation position of wedge-type stop (1) on B-pillar of driver and/or passenger side is **not correct (NOT OK)**, proceed to step 2.
2. Correct the installation position of wedge-type stop (1, Figure 1) on B-pillar of driver **and/or** passenger side of vehicle:

Correct the installation position of either **1 or both** wedge type stops (1) depending on results of step 1.

Remove bolts (2) of wedge-type stop (1) and remove wedge-type stop (1).
-

Reinstall the wedge-type stop (1) with cutout (3) facing **towards the vehicle's interior** (arrow).
-

Torque bolts (2) to 5 Nm.

The bolts (2) must be replaced (do not reuse bolts).
