Campaign No. 2016100002, November 2016

SUBJECT: **Models 906, Model Year 2016**
Check (Threaded) Connection of Passenger Bench Seat - Seat Belts,
Correct if Necessary

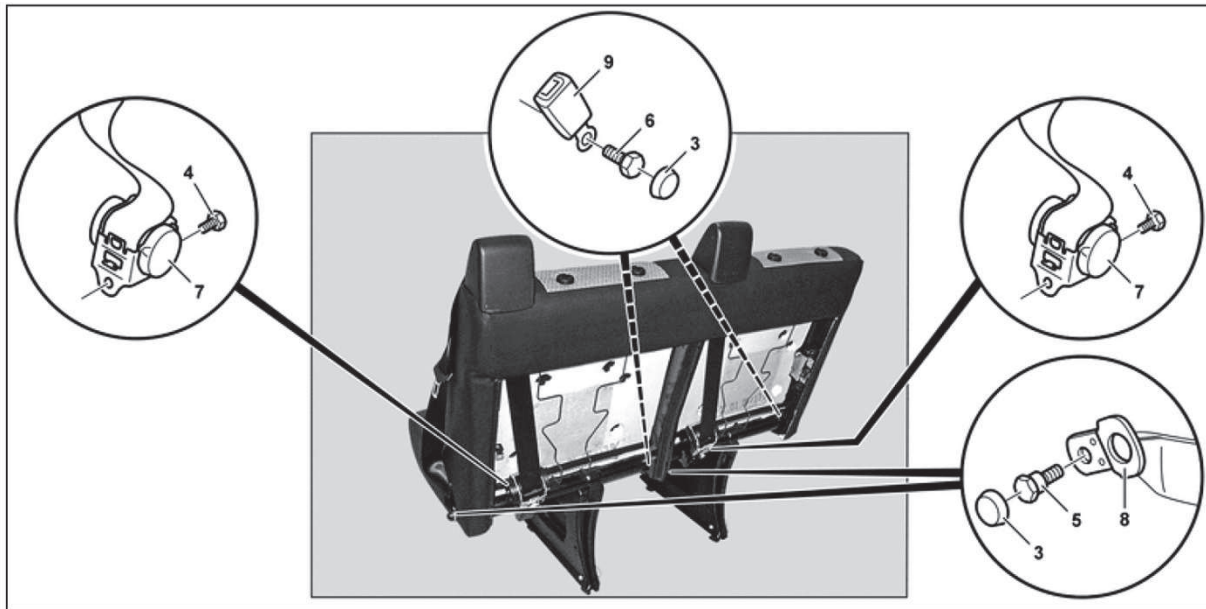
Figure 2 (7: Seat belt retractor; 8: Seat belt end fitting; 9: Seat belt buckle)

Daimler AG (DAG), the manufacturer of Mercedes-Benz and Freightliner Sprinters, was informed that the bolts on the lower seat belt anchorages for the rear bench seats on certain MY16 Sprinter vehicles may not have been properly torqued during assembly at the seat supplier. If the bolts are not properly torqued, the connection of the seat belt to the bench seat and thus the correct functioning of the belt is not ensured. This can increase the risk of injury in a crash. An authorized Sprinter dealer will check, and if necessary, correct the relevant bolt torque on the affected vehicles.

Remove bolt caps (3, Figure 2) if equipped.
3.

Check tightening torque of seat belt retractor bolts (4, Figure 2), belt end fittings bolts (5), and seatbelt buckle bolts (6) on all passenger bench seats in vehicle:
 -

Tightening torque for **all** mounting bolts (4, 5, 6) must be **37 Nm**.
 - If tightening torque is **OK** (on all bolts): Reassemble in reverse order - Procedure is then complete.
 - If tightening torque is **NOT OK**: Check that seat belt retractors (7), belt end fittings (8) and seat belt buckles (9) are correctly seated (correct as necessary) then correct tightening torque of mounting bolts to: **37 Nm**.
