star bulletin

Date:	January 3, 2013	
Order No.:	S-B-58.40/162	
Group:	58

SUBJECT: MY-All, Models All Multiplexer

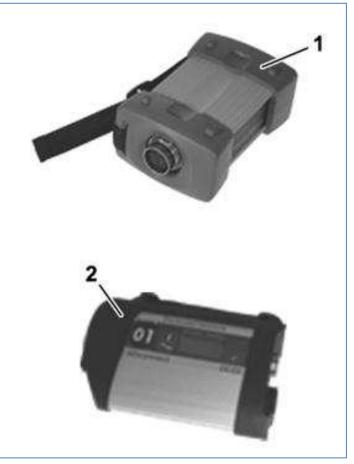
Figure 1.

There are variations in the way certain multiplexers work with various models. For all vehicles up to model 222 S-Class Star Diagnosis Basic² (Figure 2) (3) with multiplexer (Part D3) (figure 1) (1), Star Diagnosis Compact³ w (Figure 2) (4) with multiplexers SDconnect (Figure 1) (2), or Part D3 (Figure 1) (1), and Star Diagnosis Compact⁴ (Figure 2) (5), with multiplexers SDconnect (Figure 1) (2), or Part D3 (Figure 1) (1), can be used as well as XENTRY Connect Kit (Figures 3-4) (6-7).

2 SDconnect

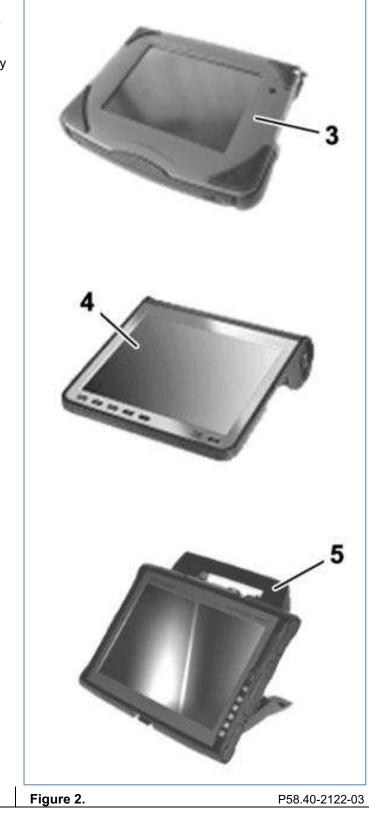
3 Star Diagnosis Basic²
4 Star Diagnosis Compact³ w
5. Star Diagnosis Compact⁴

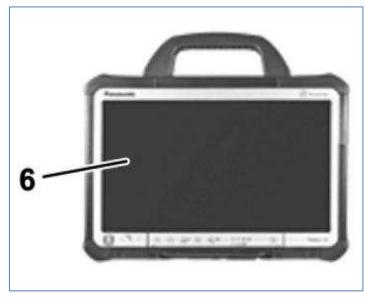
Figure 3.

NOTE: XENTRY Tab (Figure 3) (6) can only work with XENTRY Connect (Figure 4) (7). 1 Part D3

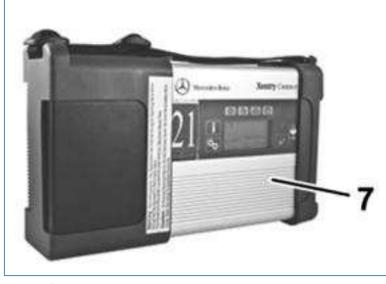
Figure 4.

7 XENTRY Connect

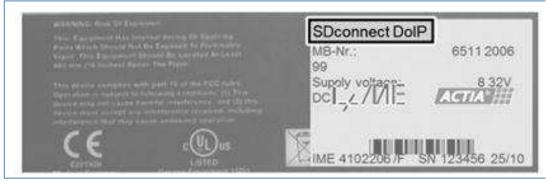
SDconnect DoIP devices for diagnosis of the model 222 S-Class have "**SDconnect DoIP**" on the model plate of the device (system number 170000 or higher) (Figure 5). SDconnect DoIP includes an Ethernet switch, which switches the TCP/IP messages in the event of DoIP diagnosis to the vehicle side.

DoIP-compatible on-board diagnosis cables have yellow marking tape at both ends and this is the only cable that works with the SDconnect system number 170000 or higher. If the number is illegible on the system number sticker, please look at the main factory sticker (Figure 5) for the wording, "DoIP."
