## star bulletin

Order No.:
 S-B-42.10/123

## SUBJECT: MY-All, Models All Cleaning Axle Hubs When Installing Brake Discs

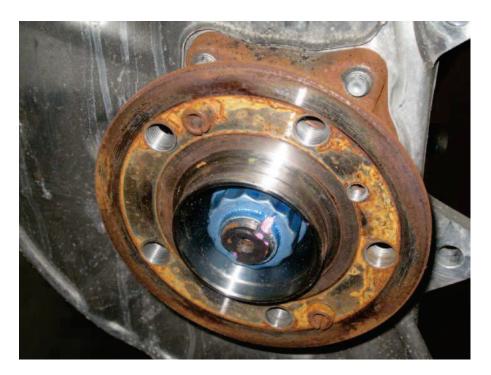
## Figure 1.

It is imperative that when installing brake discs (front or rear) the excessive corrosion / scaling (Figure 1), which may have developed on the axle hub, be removed. Use a conventional wire brush or similar tool to remove the corrosion / scaling over the entire area where the brake disc mounts to the hub flange.

Failure to remove the corrosion / scaling may cause an excessive build-up which can create adverse forces that may result in brake vibrations / judder.
